AFWAL-TM-79-10

**TEST REPORT ON INFRARED
WARNING RECEIVER (IRWR) FLIGHT
VIBRATION MEASUREMENTS**

APRIL 1980

This test report presents data which define the vibration environments experienced by two infrared warning receiver (IRWR) units mounted on the HH-53 helicopter and the C-130E transport aircraft.

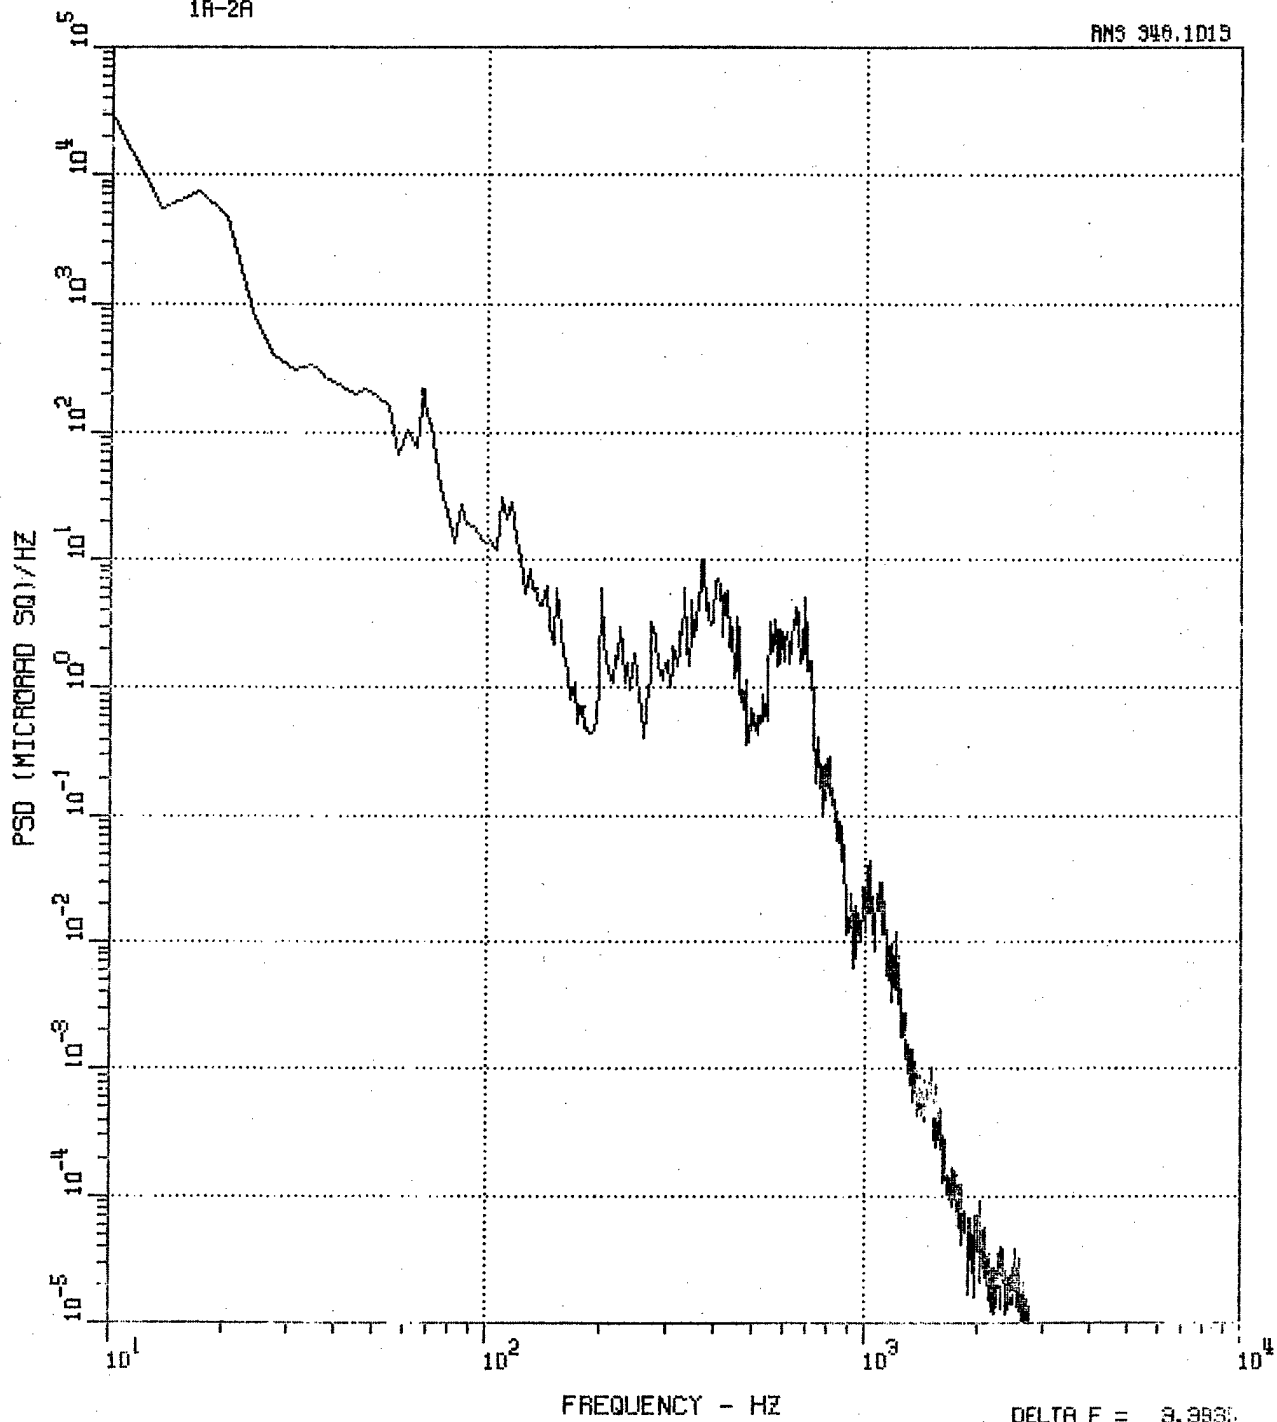
Figure 99. C-130 Aft Roll PSD, 1A-2A, 1000 Ft, 250 Kt, 30 Deg. DELTA F = 3.9835

Several pairs of linear accelerometer signals on the C-130 were combined to produce a measure of the angular accelerations experienced by the sensors. The sensors chosen are shown in Table 7 and the results are shown in Figures 96-100 for the selected flight condition of 250 knots, 30° bank, and 1000 feet altitude. The results, shown in PSDs of microradians squared per hertz, are for information only and were not used to evaluate the sensor vibration environments.

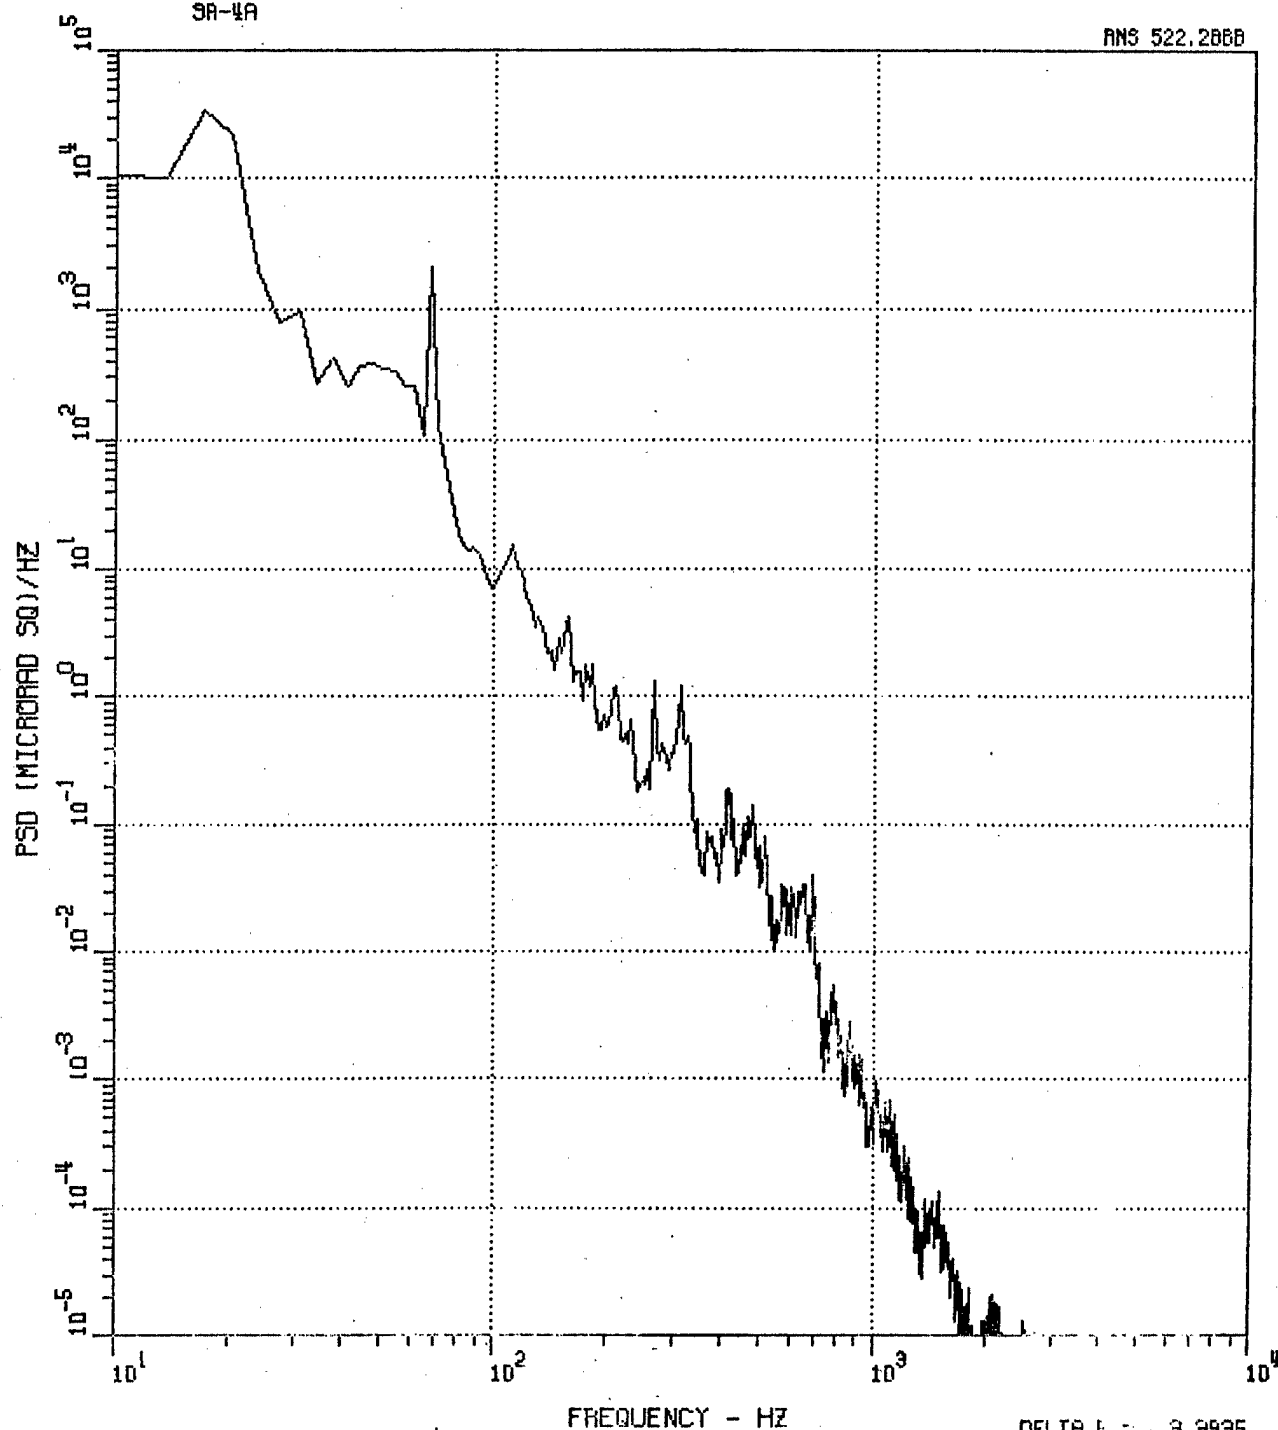
Figure 100. C-130 Aft Pieth PSD, 3A-4A, 1000 Ft, 250 Kt, 30 Deg. DELTA F = 3.9935
